## ST-1, Ashley Cove

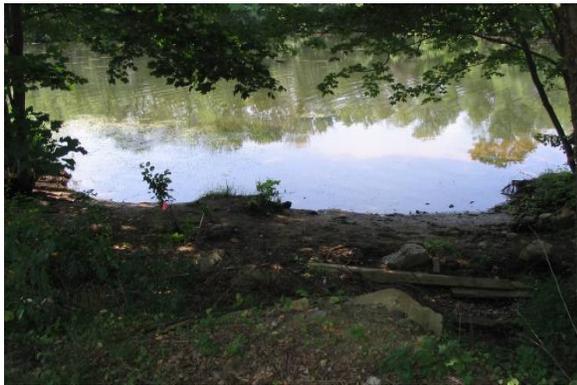
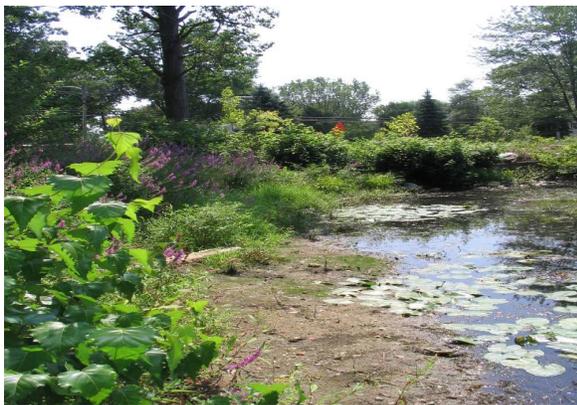
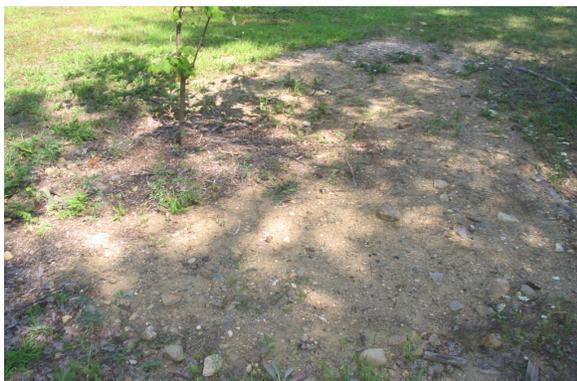
**Problems:** There are a number of invasive species located in Ashley Cove, including Eurasian watermilfoil (*Myriophyllum spicatum*), an aquatic macrophyte, and semi-aquatic / terrestrial species such as purple loosestrife (*Lythrum salicaria*), tree of heaven (*Ailanthus altissima*), and Japanese knotweed (*Polygonum cuspidatum*).

A restoration planting project was conducted at Ashley Cove at in May 2006. Native species such as red maple (*Acer rubrum*), grey dogwood (*Cornus racemosa*) and witch hazel (*Hamamelis virginiana*) were planted along 400 feet of shoreline. With this shoreline stabilization project complete, there remains approximately 150 linear feet of the cove shoreline that is unvegetated and exhibits signs of erosion.

In addition to experiencing shoreline erosion, the cove experiences high rates of sedimentation from the watershed, which results in an in-filling of near shore areas. In turn, such in-filling negatively impacts littoral habitat which is used by many fish for spawning, as well as the ability to easily access the lake for recreational use. In-filling also promotes the further establishment of nuisance stands of submerged macrophytes, particularly invasive species such as Eurasian watermilfoil.

***Invasive species management.*** Mechanical weed harvesting is currently used by the Lake Hopatcong Commission (LHC) for the control of excessive densities of aquatic macrophytes, with an emphasis placed on invasive species such as Eurasian watermilfoil. The physical and/or chemical removal of the purple loosestrife should be implemented, in conjunction with planting some select areas of the infested and unvegetated sections of shoreline with native vegetation. In addition, an educational program should be developed that provides information on the identification of the known invasive species, as well how to physically remove and properly dispose of such species.

***Shoreline stabilization.*** A continuation of shoreline planting at Ashley Cove is recommended. Assuming the targeted 150 linear feet of eroded shoreline is targeted for stabilization, such a project is estimated to cost approximately \$6,000.00 to \$7,000.00 if no machinery is necessary to re-grade the shoreline and the project only entails the planting of wetland and semi-aquatic vegetation. However, if machinery is required to re-grade the shoreline, additional labor and material costs would result in the project costing approximately \$8,000.00 to \$9,000.00. These prices include labor, purchase of materials and plants, and permitting. It should be noted that these prices assume all work would be conducted by hired contractors. The actual price of implementing this proposed project would be lower if volunteer and/or local staff (i.e. municipal employees and/or operations staff of the Commission) would participate in the project.

***Stormwater retrofits.*** Ashley Cove is located in one of the prioritized areas targeted for the installation of stormwater retrofits and Best Management Practices (BMPs), as per the TMDL-based Restoration Plan (Princeton Hydro, 2006). Thus, this site should be designed as a high priority project relative to the other locations. The Township of Jefferson and the Lake Hopatcong Commission have identified the stormwater infrastructure and the local tributaries that discharge into Ashley Cove as high priority locals for future stormwater retrofits and/or the installation of BMPs.

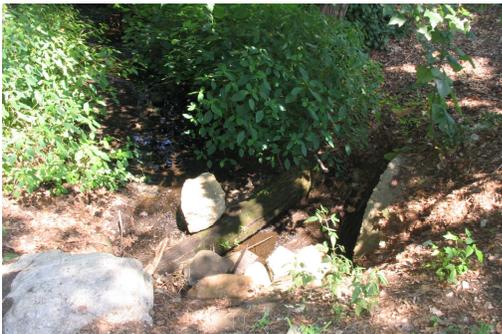
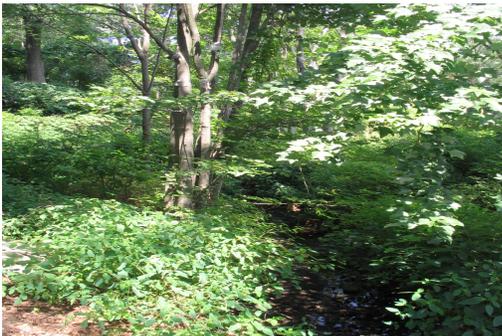
## ST-2, JP's Pizzeria

**Description:** An unnamed stream runs adjacent to the parking lot of JP's Pizzeria on Brady Road in Jefferson Township, Morris County. This stream has a well developed riparian corridor dominated by herbaceous plants.

**Problems:** This site lies on private property presenting a potential obstacle for restoration efforts. A make shift dam is present and is constructed of railroad ties across the channel at an outfall pipe. As a result, the channel has become inundated with sediments.

**Education/ Outreach.** Due to the constraints of private ownership of the site, options are limited. Therefore, educating the property owner about appropriate stream stewardship appears to represent the best option for restoration.

**Removal of sediments.** Once the source of the sediment loading has been identified and addressed, the project of removing the sediment bar can be undertaken. It should be emphasized that any earth-moving activity near a waterway, whether a streambank stabilization project or the removal of a sediment bar, requires a permit through the New Jersey Department of Environmental Protection. Typically, the municipality and/or private landowner is responsible for obtaining the required permits. However, the Lake Hopatcong Commission may be able to assist in design, permitting or implementation of the project. The estimated cost to remove the sediment bar is dependent primarily upon the amount of sediment targeted for removal.

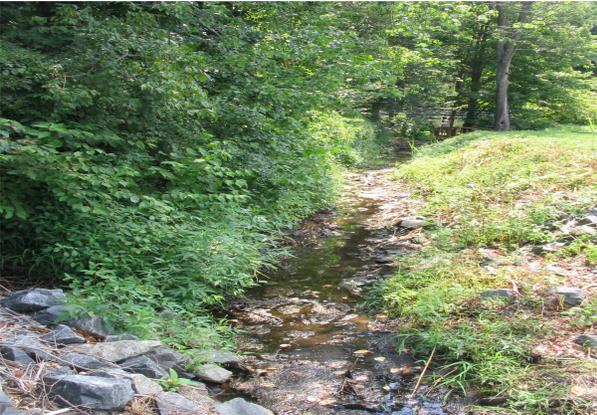
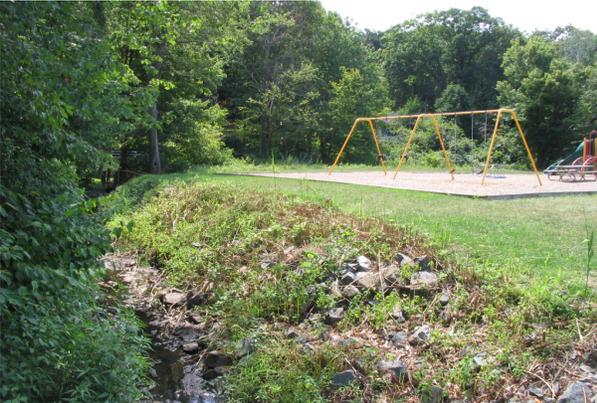
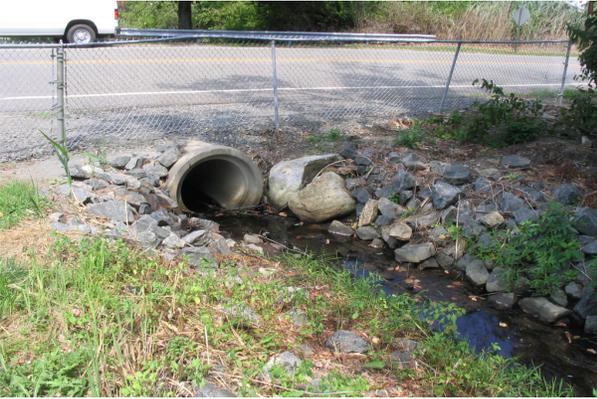
**ST-3, Benedict's Lagoon (continued)**

**Problems:** The stream that drains to Benedict's Lagoon is currently in the initial stages of being infested with several invasive species, including common reed (*Phragmites australis*) and Japanese stiltgrass (*Microstegium vimineum*).

As the stream runs through a playground, stretches of the bank lack a proper riparian buffer. The lack of buffer is also contributing to the visible sedimentation problems in the stream. Such sedimentation of the streambed degrades the complex in-stream habitat utilized by macroinvertebrates and small fish. Extremely heavy rates of sedimentation can completely eliminate such valuable in-stream habitat.

**Streambank stabilization.** A streambank stabilization project using native species is recommended along the stretch of the stream that runs through the park. This should stabilize the banks to reduce sediment loss and increase the buffer area to increase riparian function. Using an estimate of approximately 300 linear feet targeted for stabilization, the cost to implement this project is \$11,000.00 to \$12,500.00 if machinery is required and \$8,000.00 to \$9,000.00 if no machinery is required. These price estimates include labor, materials / plants and permitting.

**Invasive species management.** Invasive species should be removed by physical or chemical means and replaced with native vegetation. As with any chemical treatment in an aquatic or semi-aquatic habitat, a licensed applicator would need to obtain a State permit to implement an invasive species control program using an approved herbicide.

**Education/ Outreach.** This site would be an ideal location for teaching the local community about how a healthy and stable watershed that addresses its generated stormwater would translate to improved in-lake water quality conditions. The installation of a baffle box BMP, the planting of native species within the stream corridor and the removal of invasive species all in proximity to each other provides an excellent opportunity for an educational kiosk or as a site for environmental/watershed education events.

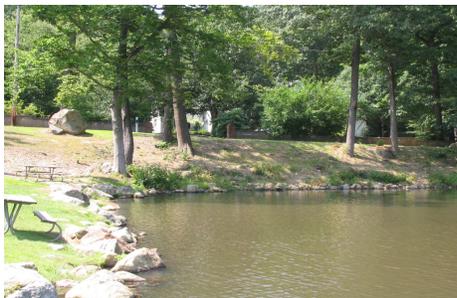
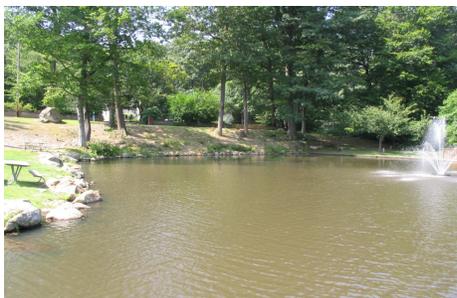
## ST-4, Memorial Park

**Problems:** A small pond is located at Memorial Pond. This pond has had sedimentation problems since the 1990's and was dredged in the late 1990's with funds provided by US EPA. The shoreline of the pond is bare and stabilized with large rocks at the base of the banks. The presence of tall trees on the edge of the pond is also of concern. Since the banks of the pond are losing sediment in the absence of stabilizing vegetation, there is potential for the trees to fall into the pond. Memorial Park is used by young children and densely surrounded by residential homes, causing concern for public safety.

***Shoreline stabilization.*** To improve site aesthetics, decrease sedimentation to the pond, and calm public safety concerns, the banks of the pond at Memorial Park should be revegetated using native plants. If no mechanical equipment is necessary for shoreline planting along Memorial Pond and the total length of stabilization is approximately 300 linear feet, a shoreline planting project of the pond is estimated to cost between \$8,000.00 to \$9,000.00

Memorial Park, including Memorial Pond has already been identified as a prioritized site, targeted for the installation of stormwater retrofits and Best Management Practices (BMPs), as per the TMDL-based Restoration Plan (Princeton Hydro, 2006). Thus, this site should be designed as a high priority project relative to the other locations. Additionally, Memorial Pond is upstream of a site identified for some major stormwater infrastructure retrofits to reduce Mount Arlington's relative contribution to the lake's phosphorus, as described in the TMDL-based Restoration Plan.

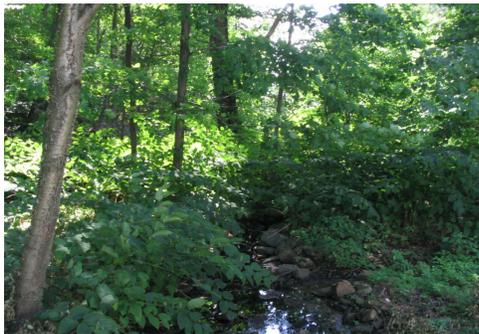
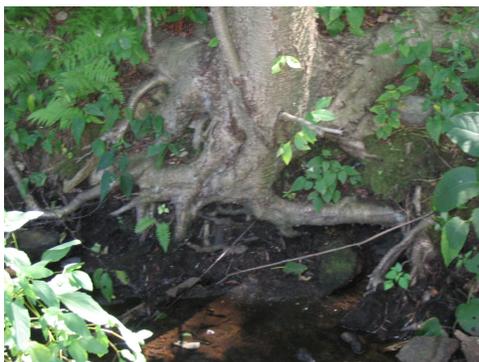
## ST-5, Howard Boulevard

**Problem:** The stream along Howard Boulevard is severely eroded. Impervious surfaces from a nearby shopping area lie within 50 feet of the stream bank. Large amounts of sheet flow from the immediate areas inundate the stream channel during storm events and are responsible for most or all of the extensive erosion. In addition, this stream corridor is infested with the invasive species Japanese knotweed (*Polygonum cuspidatum*).

**Invasive Species management.** It is recommended that removal of Japanese knotweed by physical or chemical means should be coupled with replacement with native species.

**Streambank Stabilization.** In addition to the removal of the invasive species and planting of native species, some additional structural work (i.e. re-grading, installation of rip-rap) is recommended.

**Stormwater retrofits.** It may be possible to work with the property owners of the shopping area to install retrofits into the existing stormwater infrastructure to reduce the magnitude of the pollutant loads. It may also be possible to install small-scale infiltration BMPs into the existing parking lot in an effort to reduce the magnitude and force of the water that leaves the site and contributes toward the observed streambank erosion.

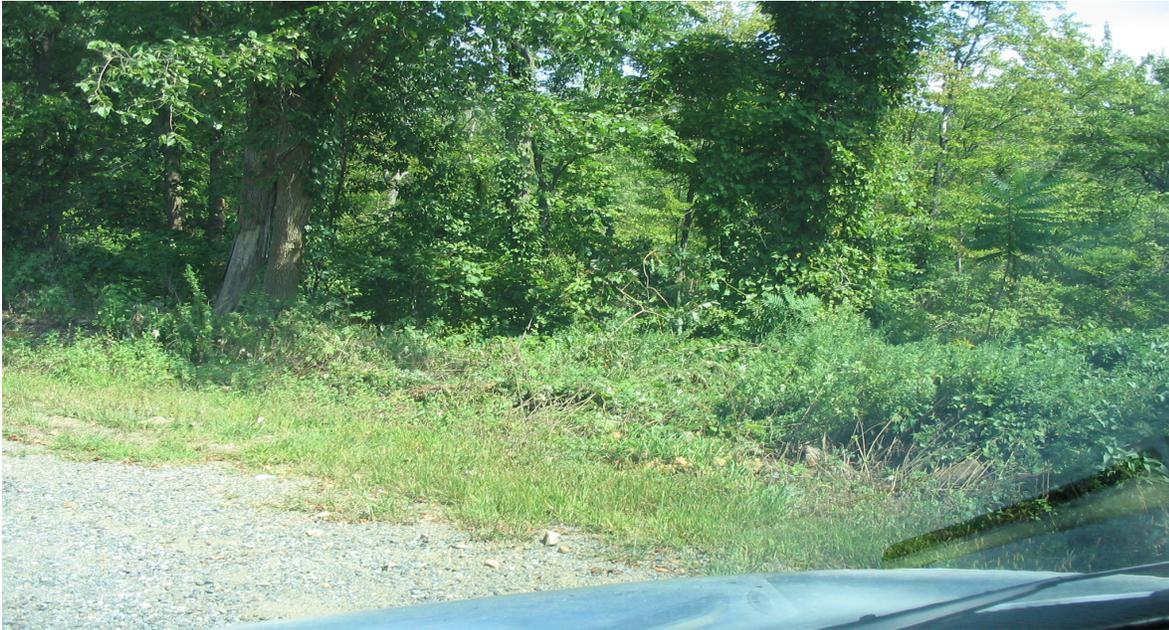
## ST-6, Oneida and Mountain View

**Description:** The site at Oneida and Mountain View is located in the Borough of Mount Arlington, Morris County and was overgrown with the invasive species Japanese stiltgrass (*Microstegium vimineum*) and tree of heaven (*Ailanthus altissima*). Due to the high level of growth, access to the stream site was very limited. Thus, this did not allow for a thorough site evaluation at the time. At a minimum, some physical or chemical removal of the invasive species should be conducted, followed by the stabilization of the site with native species.

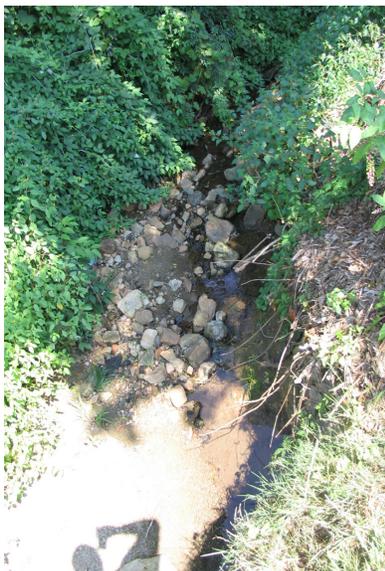
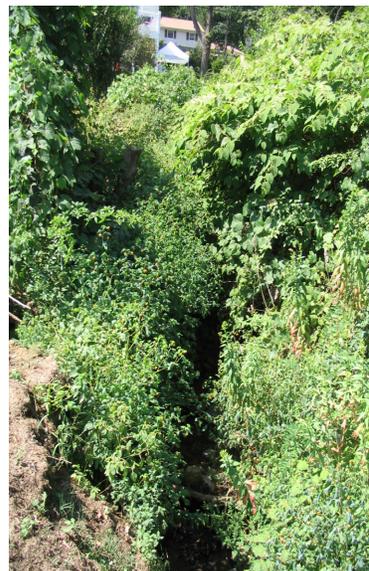
## ST-7, Ingram Cove

**Problems:** Conditions in the cove include high concentrations of filamentous algal mats as a result of prevailing winds and high densities of the invasive aquatic macrophyte Eurasian watermilfoil (*Myriophyllum spicatum*). A stream flows into the cove draining Ingram Road. Extensive erosion, sedimentation and large amounts of woody debris were observed in the streambed at the time of the site evaluation. While the stream's upper banks are generally well vegetated the "lower" end of the stream, closer to the lake, displays a deep channel and severely eroded streambanks.

**Stormwater retrofits:** Due to the recognized problems experienced at Ingram Cove, Ingram Road was selected for a large-scale BMP installation project to reduce the pollutant loads (i.e. total phosphorus and total suspended solids) entering the cove as part of a Non-Point Source grant awarded to the Lake Hopatcong Commission by the New Jersey Department of Environmental Protection. Unfortunately, due to site-specific complications associated with existing underground utilities, this project had to be moved to another site within the Borough of Hopatcong. However, retrofitting the existing catch basins along Ingram Road is still a potential option, which may be implemented as part of an upcoming US EPA Targeted Watershed grant.

**Streambank stabilization:** Some streambank stabilization efforts along 50 to 100 linear feet of stream edge is estimated to cost between \$5,000.00 and \$7,000.00, including labor, materials, plants and permitting. It should be noted that this cost does not include the use of any machinery to re-grade the streambank. Additionally, permitting of any restoration project at this site may be a little more complicated relative to other sites in the watershed.

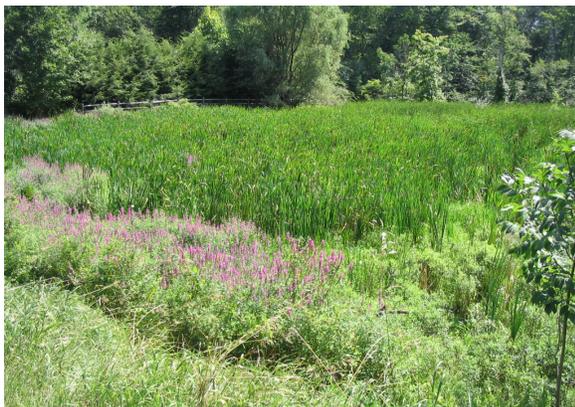
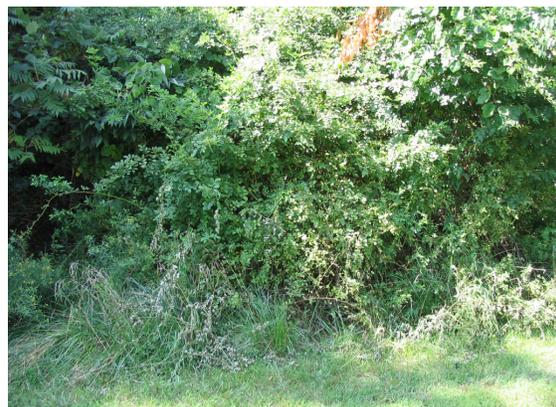
## ST-8, DuPont Avenue

**Problems:** Extensive invasive species infestation is visible at the wetland and surrounding area at DuPont Avenue. Invasive species include: purple loosestrife (*Lythrum salicaria*), multiflora rose (*Rosa multiflora*) and Japanese stiltgrass (*Microstegium vimineum*). Of particular concern is the quick colonization of the wetland itself by the purple loosestrife.

***Invasive species management.*** The physical and/or chemical removal of the purple loosestrife and Japanese stiltgrass should be implemented in conjunction with planting native obligate wetland species. The removal of multiflora rose will be more intensive and may require the use of mechanical devices.

The quick colonization of purple loosestrife is reducing the overall plant diversity of the wetland basin. In turn, this reduction in native vegetation will impact the wildlife value of the wetland BMP. Additionally, a particularly large accumulation of purple loosestrife in the basin may eventually impact the hydrology and functionality of its pollutant removal capacity. Thus, in order to ensure that the basin is operating at its optimal capacity to remove pollutants, the purple loosestrife needs to be eradicated and it should be re-planted with native wetland species.

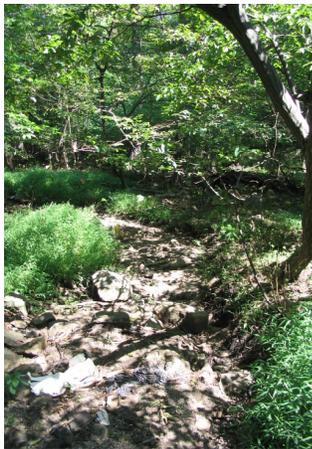
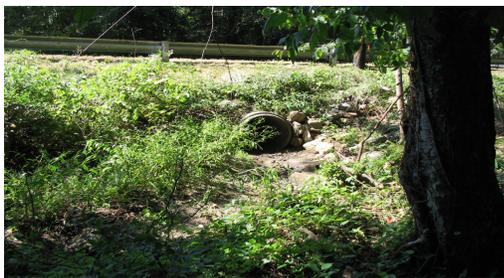
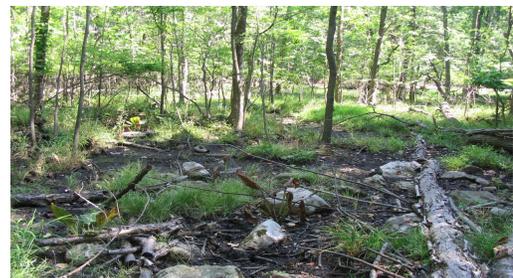
## ST-9, Maxim Road

**Problems:** The wetland area at Maxim Road is infested with the invasive species, Japanese stiltgrass (*Microstegium vimineum*). There is also a large amount of litter, debris and sediment in the stream channel, most likely the result of drainage during storm events.

***Invasive species management.*** The physical and/or chemical removal of Japanese stiltgrass should be implemented in conjunction with planting native obligate wetland species.

***Stormwater retrofits.*** In order to decrease the amount of sediment and debris entering this area, it is suggested that the stormwater infrastructure along Maxim Road be examined for possible stormwater retrofits or perhaps the installation of a larger BMP device to reduce the pollutant loads entering the wetland and ephemeral stream habitat.

***Streambed restoration.*** The streambed at the Maxim Road site needs to be restored after the source of the debris and sediment is addressed. A more detailed assessment should be conducted to assess how best to stabilize and, possibly if needed, re-configure the streambed.

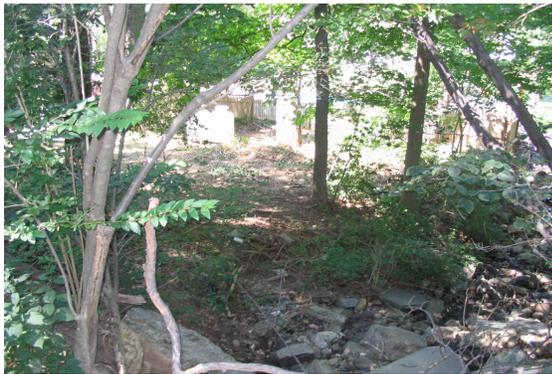
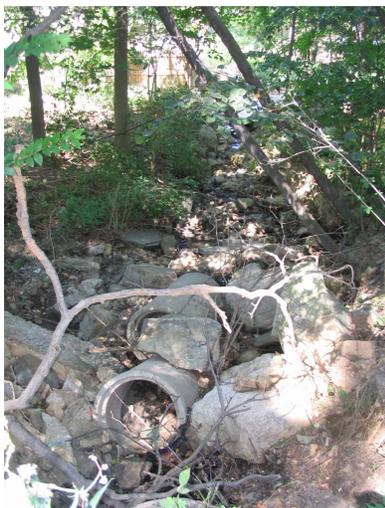
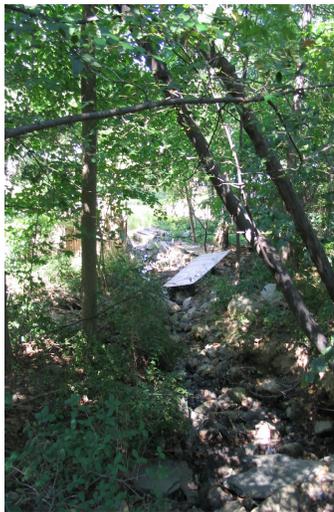
## ST-10, Lakeside Boulevard and Sharp Avenue

**Problems:** The stream located at Lakeside Boulevard and Sharp Avenue is within a residential section of the watershed. A deteriorating outfall pipe is present at the site. Significant bank erosion is also evident with railroad ties in the stream channel.

**Stormwater retrofit.** It is recommended that the failing outfall pipe be replaced with an upgraded pipe. A scour hole lined with rip-rap should be designed and placed immediately below the upgraded pipe to reduce the velocity of the storm flow and settle out some of the solids. Railroad ties should be removed and, where needed, the banks should be stabilized with rip-rap and/or native vegetation (see below).

**Streambank stabilization.** Native species should be planted along the stream corridor to improve riparian function and stabilize banks.

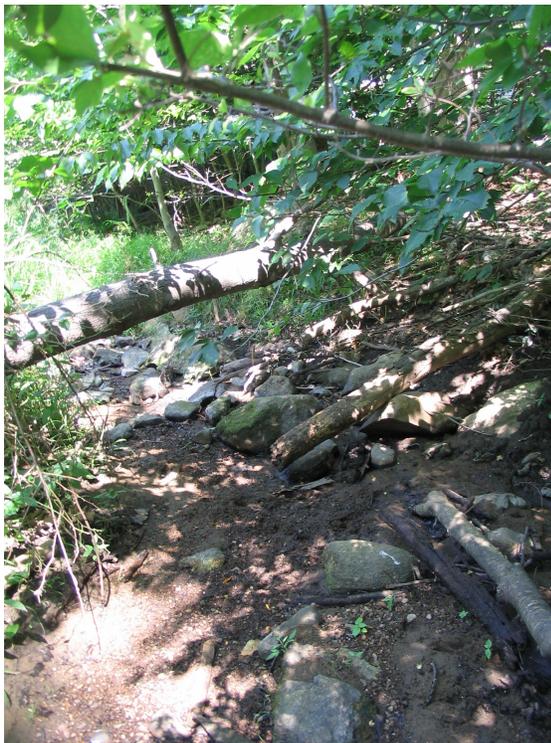
## ST-11, Ford Avenue

**Problem:** Due to the existing subdivision in the immediate vicinity of this site, drainage issues are having more of an impact on the Borough of Hopatcong. This site is borough-owned and has been identified as a potential site for stormwater retrofits by the Borough's Engineer.

**Recommendations:** Since this site is located in one of the TMDL-Restoration Plan's prioritized areas in need of stormwater upgrades / retrofits, is recommended that the Lake Hopatcong Commission continues to work in conjunction with the Borough Engineer to improve conditions at this site. Bank stabilization, vegetative enhancements and outlet structure modifications would all contribute toward increasing the pollutant removal efficiencies of the downgradient basins.

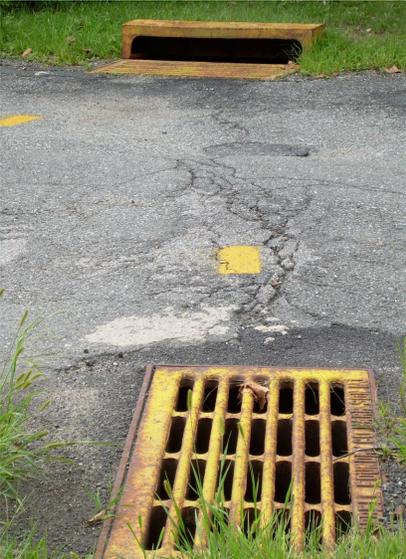
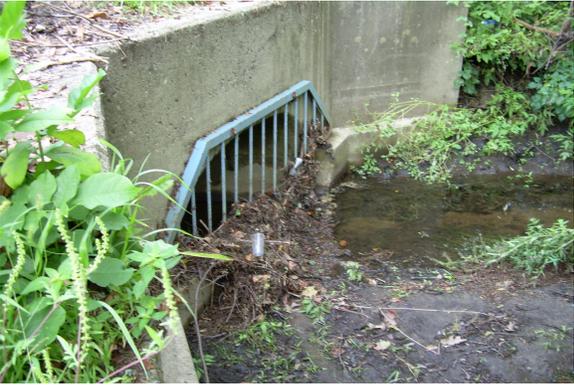
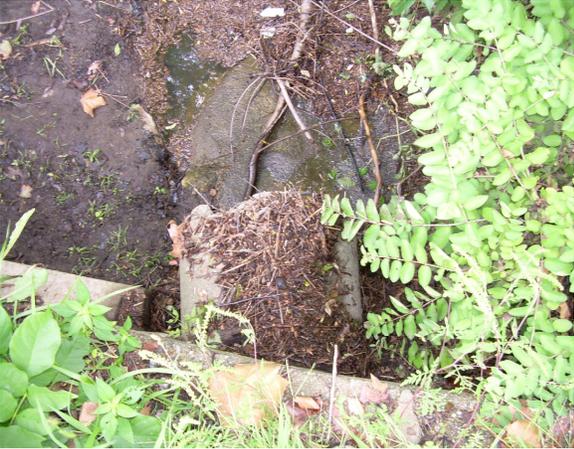
**ST-12, Edith Decker School (continued)**

**Problems:** Excess sediment has accumulated against the grate of the culvert in the stream. The stream channel has narrowed due to the accumulation of sediment. Adjacent to the stream is a driveway to the school parking lot. The catch basins in this driveway are very shallow, causing the sediment to quickly build up.

***Stormwater retrofit:*** The original plans for the US EPA Targeted Watershed Grant for this site should be implemented, a Suntree Unit or similar stormwater MTD should be installed within the stormwater conveyance system prior to the outfall into the stream. This will serve to reduce the sediment and phosphorus loading to the stream channel.

***Streambank restoration.*** The stream channel is stressed and eroded from the large stormwater volumes entering the waterway. These large stormwater volumes convey pollutants to the lake, as well as erode the streambanks. Thus, the planting of native riparian vegetation will aid in improving the functioning of this stream. However, a more detailed site assessment should be conducted to determine if more structural modification of the streambank / stream channel itself should be conducted prior to the establishment of riparian vegetation.

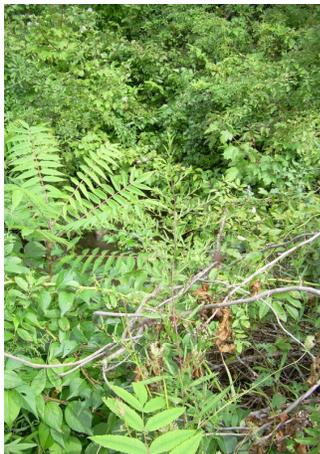
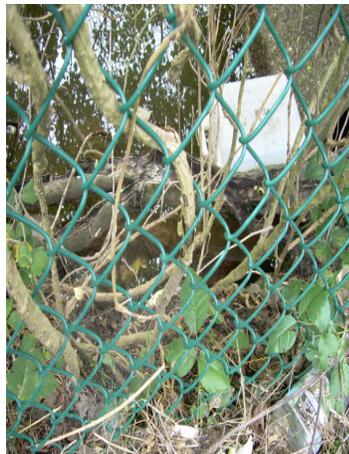
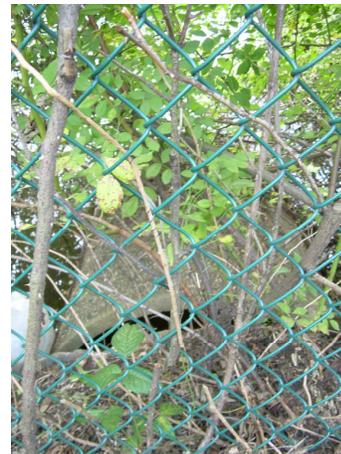
## ST-13, Quarry Brook

**Problems:** The banks of the stream were overgrown at the time of the site visit in late August 2006. The dense vegetation made it difficult to make any objective assessments of the condition of the stream.

Across the street at the lake's shore, however, the outfall pipe is cracked. The shoreline surrounding the outfall is also eroded for a length of approximately 50 feet. Overgrowth of algae and aquatic weeds such as Eurasian watermilfoil (*Myriophyllum spicatum*) are visible in the lake. A fence surrounds the lake, including the deteriorating outfall pipe.

**Stormwater retrofit.** The deteriorating outfall pipe should be repaired or replaced. It is also recommended that a retrofit should be applied such as an MTD to reduce sediment and floatables to Lake Hopatcong. The retrofit could be installed in the catch basins that convey stormwater directly to the pipe. In addition, some rip-rap should be placed immediately below the pipe to reduce erosion of the immediate area. Depending on the type of MTD used, such a retrofit and rip-rap project is estimated to cost between \$10,000.00 and \$30,000.00.

**Shoreline stabilization.** It is recommended that the fence be removed to plant an adequate buffer at this section of the lake consisting of native species. In addition, a more detailed assessment of the in-stream and near shore habitat should be conducted to determine its quality relative to fish spawning. Some additional wetland or semi-aquatic vegetation may be required to enhance the fishery habitat along this near shore section of the lake.

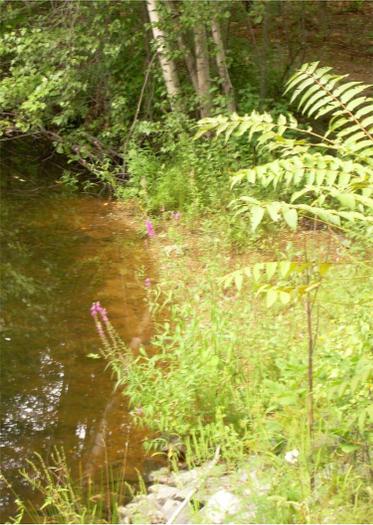
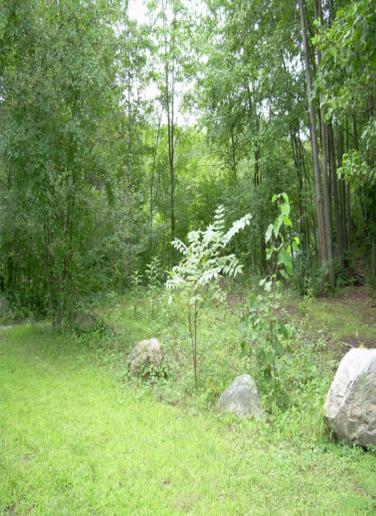
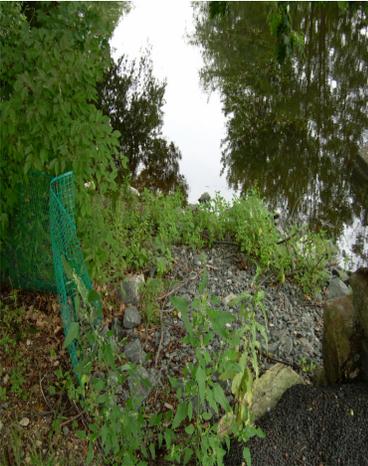
**ST-14, First Bridge on Three Rivers Drive (continued)**

**Problems:** The banks of the canal that flow under the first bridge are eroded; visible aquatic weed and algae growth are apparent. Sparse vegetation, including purple loosestrife (*Lythrum salicaria*), is present, growing in the rocks at the base of the bridge abutment on both sides of the road and bridge. At the corner of Three Rivers Drive and Venetian Drive, there is a sparsely vegetated area.

***Invasive species management.*** The existing purple loosestrife should be physically removed and then replaced with native species.

***Shoreline stabilization.*** Installing native herbaceous plants along the tow of the banks of the canal may deter further bank erosion and help filter runoff from residential lawns. However, a more detailed assessment of the banks is required. Native species plantings near the bridge abutments will also have a positive impact on the water quality of the canal.

***Stormwater retrofits.*** The corner lot of Three Rivers Drive and Venetian Drive may be a good area for wetland plantings, a rain garden and/or a bioretention system if this area is municipally-owned. At the time of this survey, there was sparse vegetation, mature trees, and a pile of grass clippings.

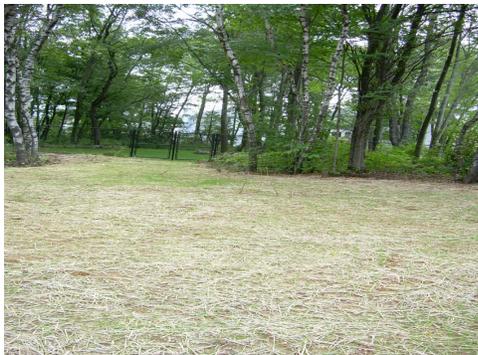
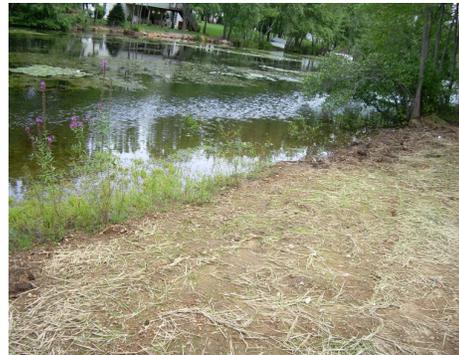
## ST-15, End of Three Rivers Drive

**Problems:** A strong septic odor was apparent in this area at time of the site evaluation. Abundant waterfowl, algae, and aquatic weed growth were present in the canal. Along the shoreline, in an area 60 feet by 20 feet, efforts were underway to establish a lawn. All other areas between the canal and fenced-in yards are vegetated. This may be an encroachment issue but nevertheless, planting of wetland plants is beneficial to stabilizing banks and purifying runoff from fertilized yards.

**Regulatory:** Possible enforcement of streambank encroachment. However, it may be more beneficial to provide information to the property owner on the value of using non-phosphorus fertilizers on the lawn once it is established and of installing some near shore, wetland plants along the lake shore to reduce the pollutant load entering the lake.

**Streambank stabilization:** The planting of turf grass should not be allowed and planting of native wetland vegetation should be encouraged. The successful implementation of a streambank stabilization project would make this bank of the canal fully vegetated as opposed to the opposite bank which is dominated by residential lawns.

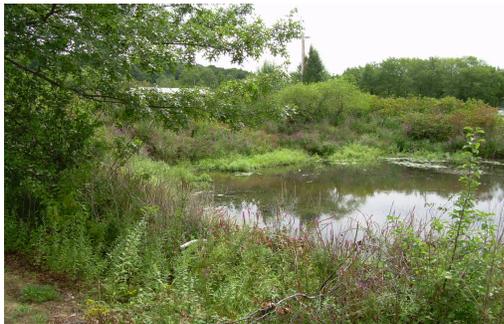
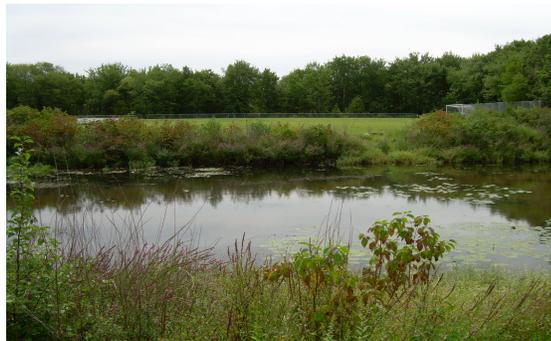
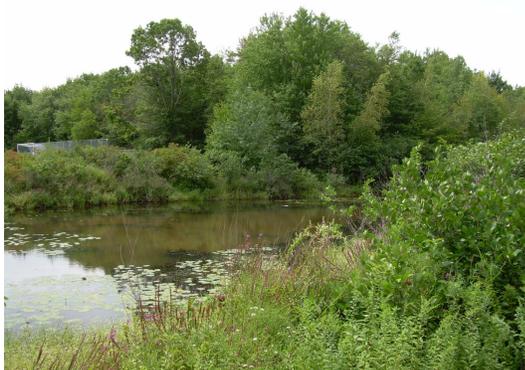
## ST-16, End of Canal at Fireman's Field

**Problems:** The banks of the canal are well vegetated but the invasive species purple loosestrife (*Lythrum salicaria*) is the dominant plant. The heaviest infestation is located along the bank of the canal at the east end of the field.

**Invasive species management.** The physical and/or chemical removal of invasive species should be implemented in conjunction with planting of additional native species. In addition, if this part of the canals is used as a site of access for water withdrawal during fires in the local area, a section of the shoreline should be cleared of the purple loosestrife and planted with low-lying herbaceous plants.
